PUBLIC HEALTH BULLETIN No. 74

INVESTIGATION OF THE POLLUTION OF TIDAL
WATERS OF MARYLAND AND VIRGINIA

SHELLFISH-BEARING AREAS

HUGH S. CUMMING

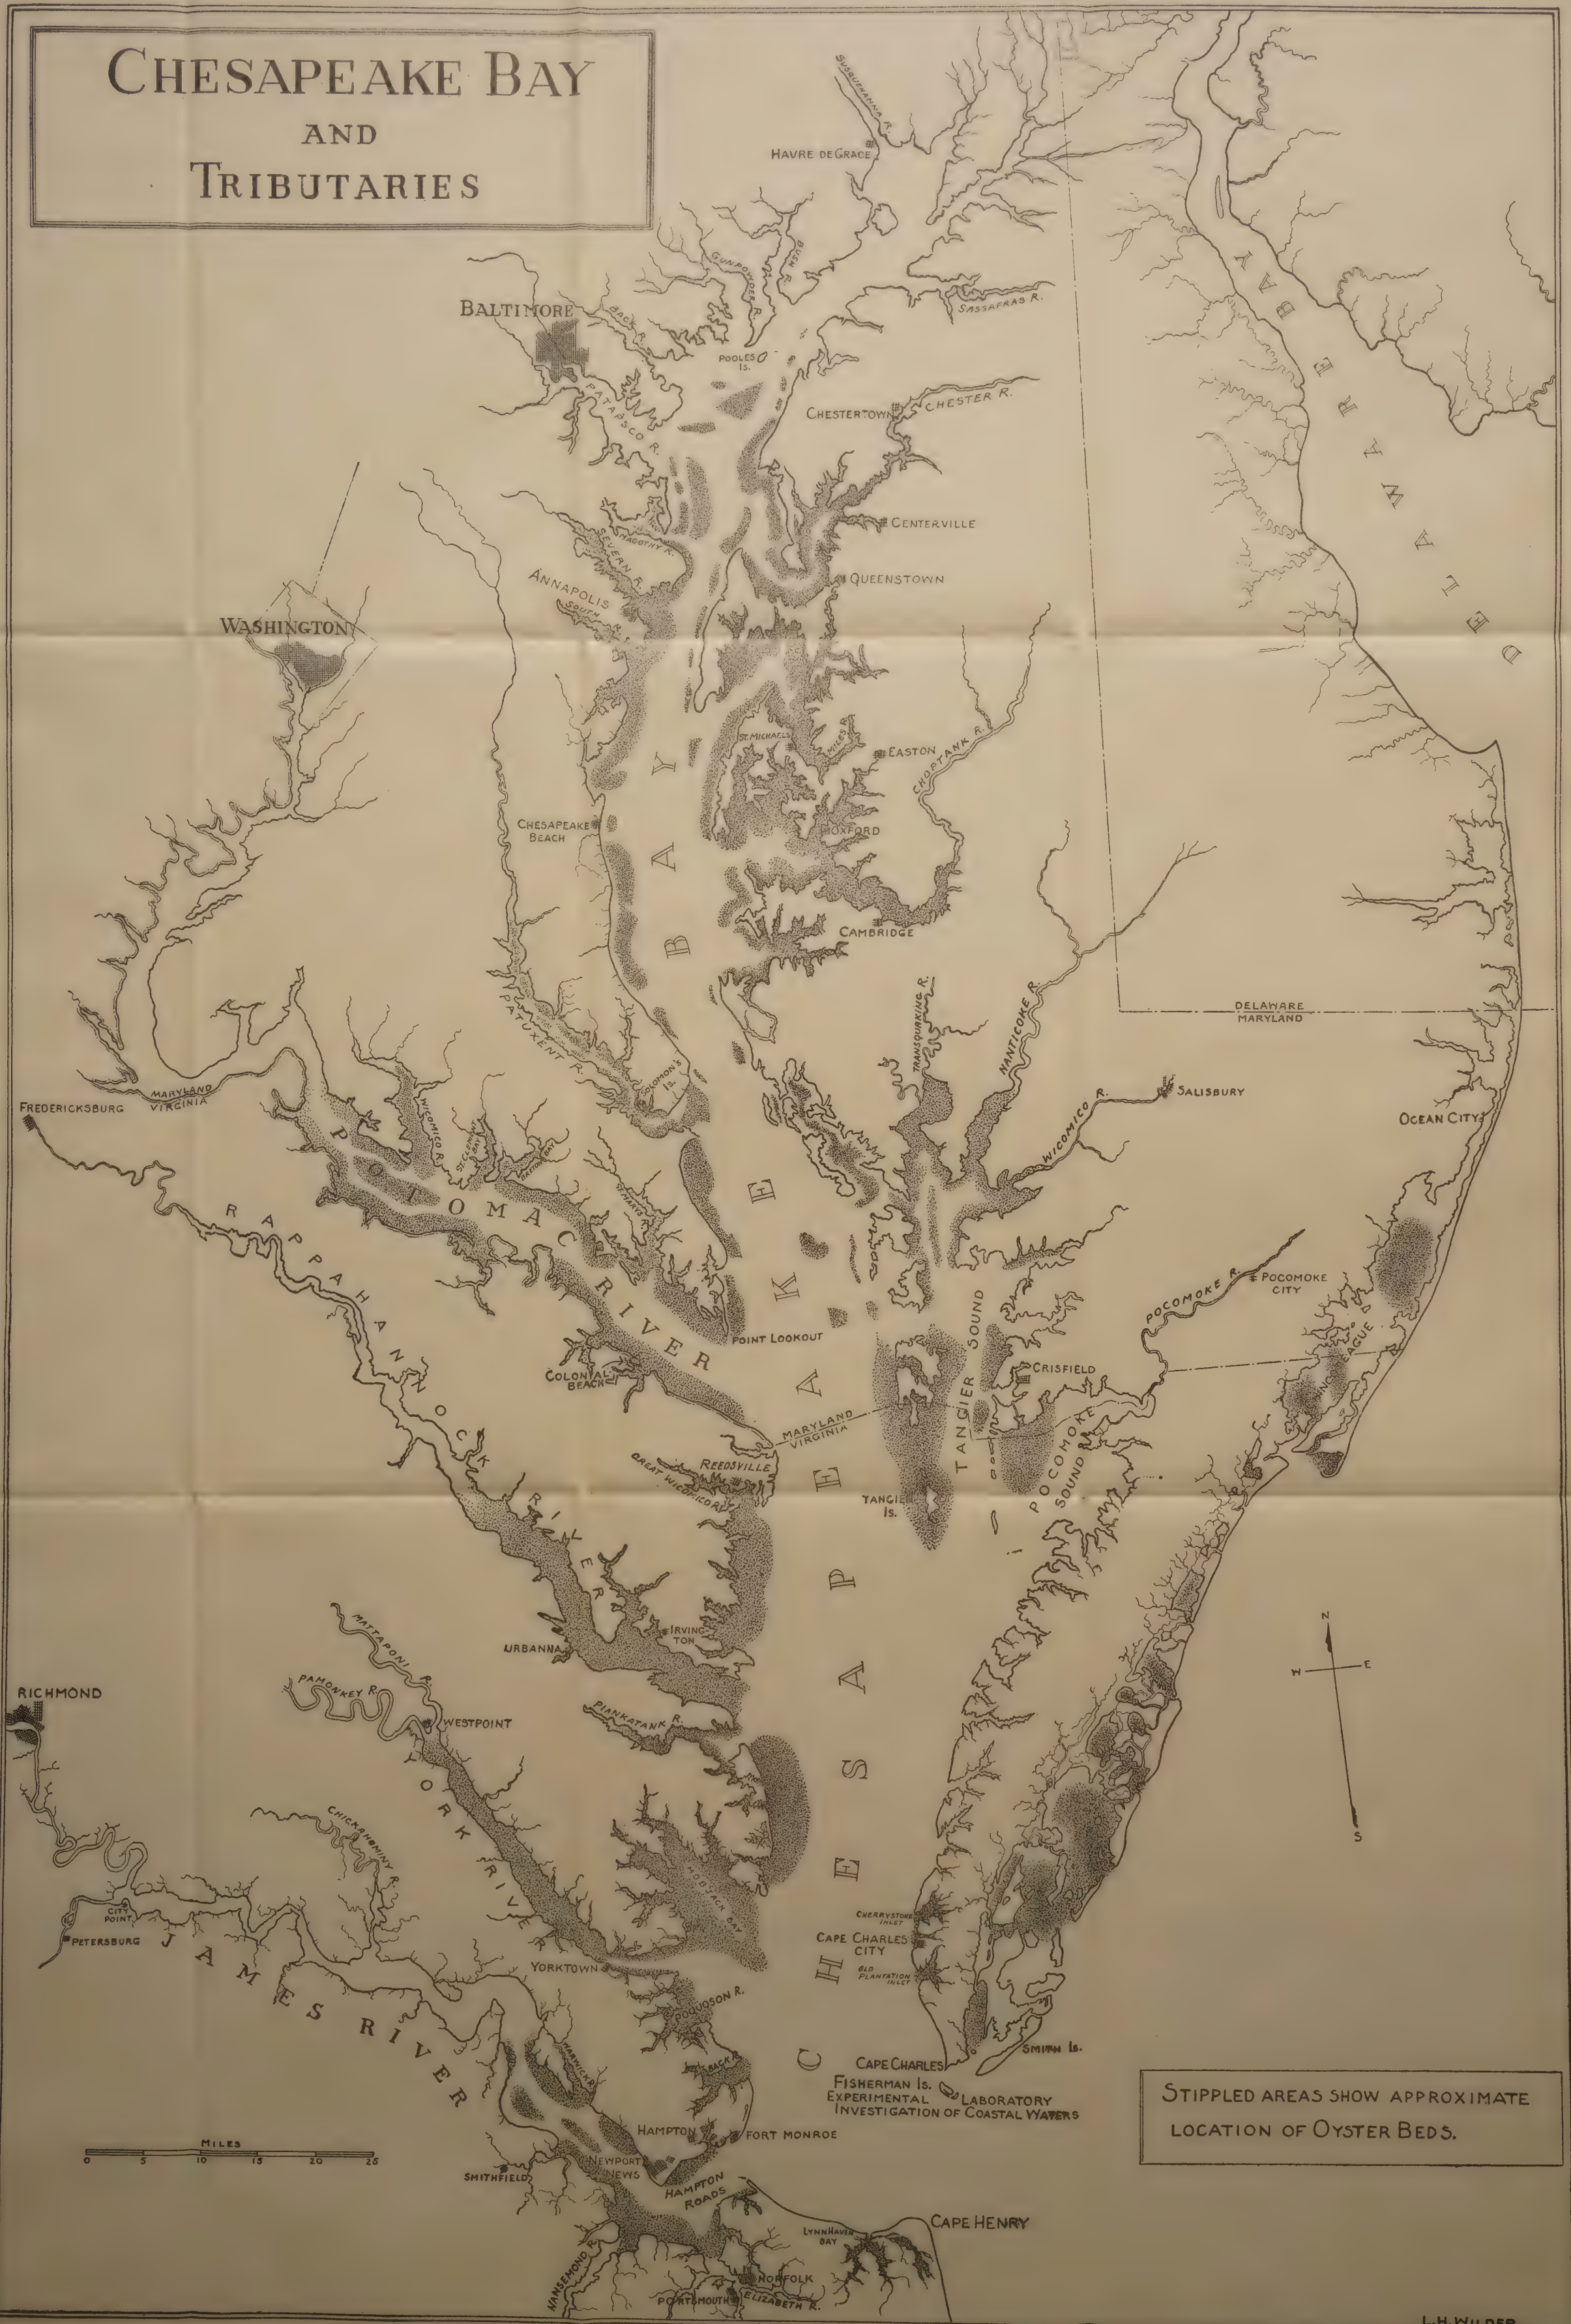
CHESAPEAKE BAY AND TRIBUTARIES

STIPPLED AREAS SHOW APPROXIMATE
LOCATION OF OYSTER BEDS.

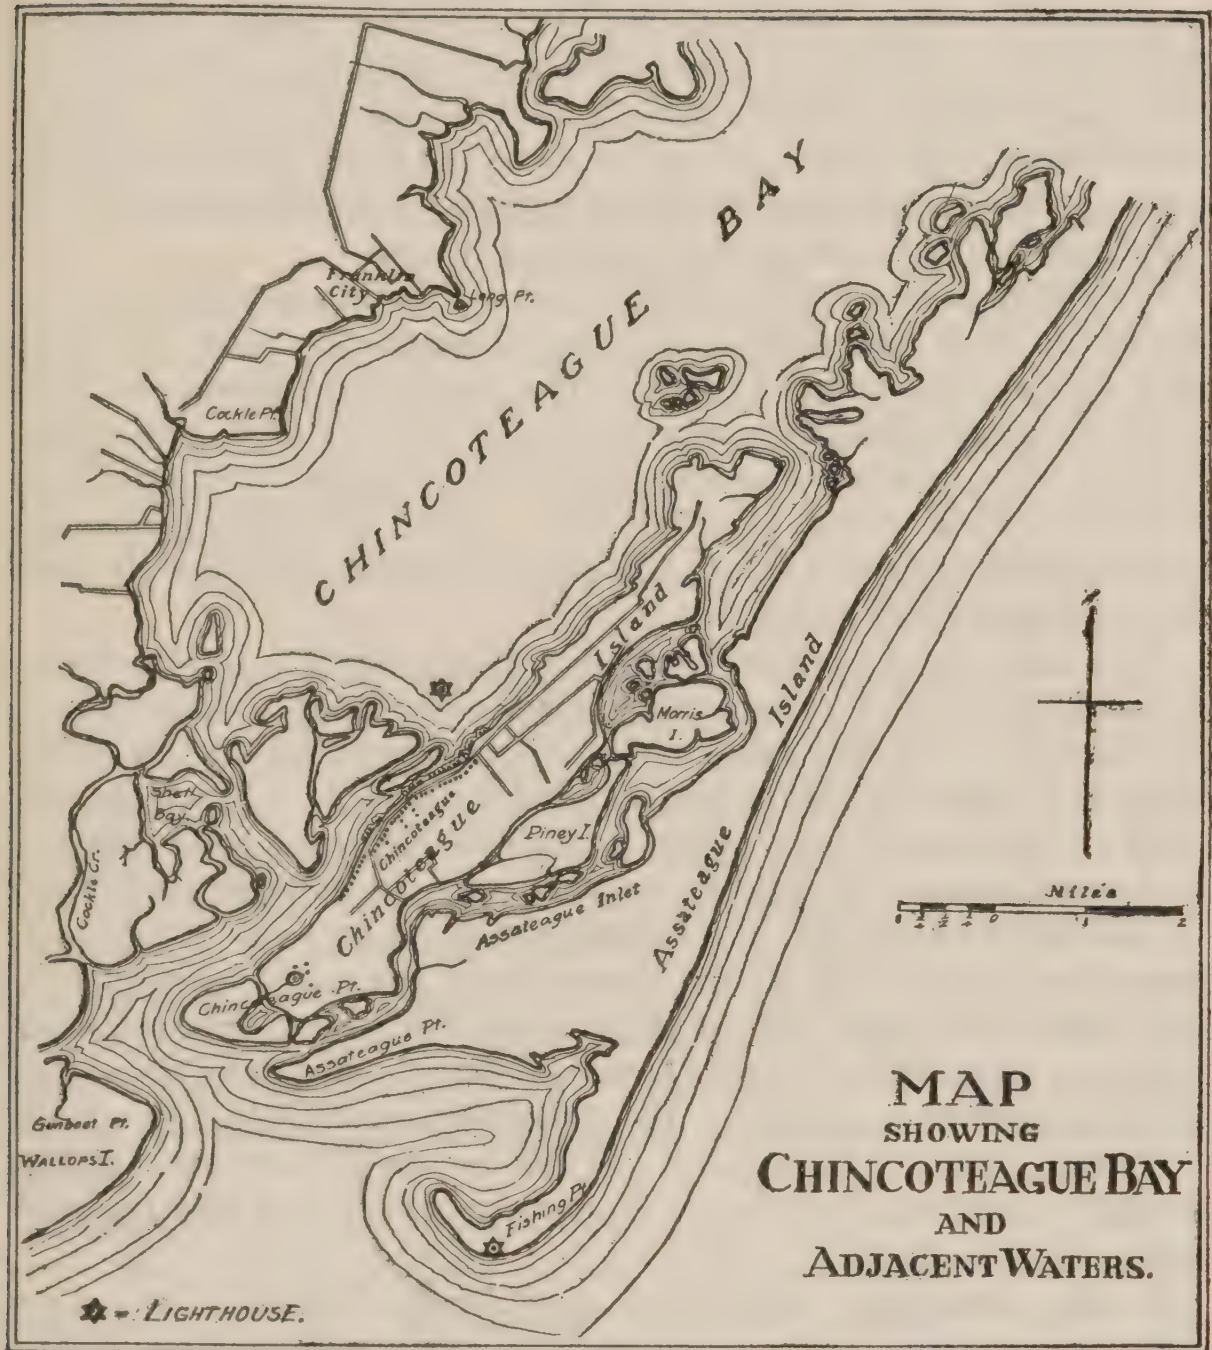
MAP NO. 3.

Chincoteague Island is the most populous island and the most important shipping center along the ocean side of the Eastern Shore. Legally it is a district of Accomac County, Va. The island is about 8 miles long, from north to south, and 2 miles broad, from east to west. The surface is a series of low dunes with intervening salt
